LIVE WATER LEAK CLAMPED WITH BELZONA

ID: 5704

Customer Location: Hospital, Northern Texas, USA
Application Date: 2011

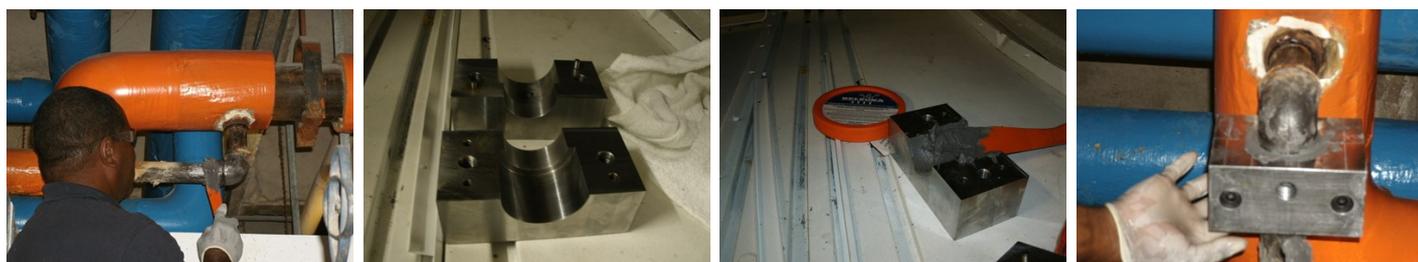
Photograph Descriptions

The hot water line was leaking from an expansion tank to the 2" line. The supply of hot water could not be shut off since it fed water to the emergency room.

- * Leaking pipe cleaned ,
- * Clamp ready to go ,
- * Application of Belzona 1111 ,
- * Clamp installed ,

A clamp was fabricated at a machine shop. The clamp had a threaded drain and matched threaded fittings. Belzona 1111 was applied to secure clamp to the hot water line.
