BELZONA BEARING HOUSING REPAIR

ID: 571

Exhauster fan bearing housing

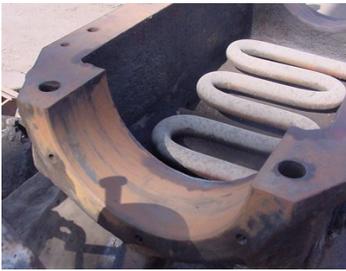
Oversized bearing housing due to bearing failure.

- * General view of the bearing housing ,
- * Rebuilding of bearing housing using forming technique ,
- * Bearing housing after repair ,
- * The upper part of bearing housing repaired ,

Belzona repaired the worn out bearing housing without welding or machining, preventing the heat distortion of coventional welding repairs. A special adjusting part has been fabricated to ensure accurate dimensions.
