Pintle Housing Repair with Belzona

Industry: *Marine*
Application: *SOS-Ships and Offshore Structures*

Customer Location: *Cement transportation ship, Egypt*
Application Date: *July 2004*

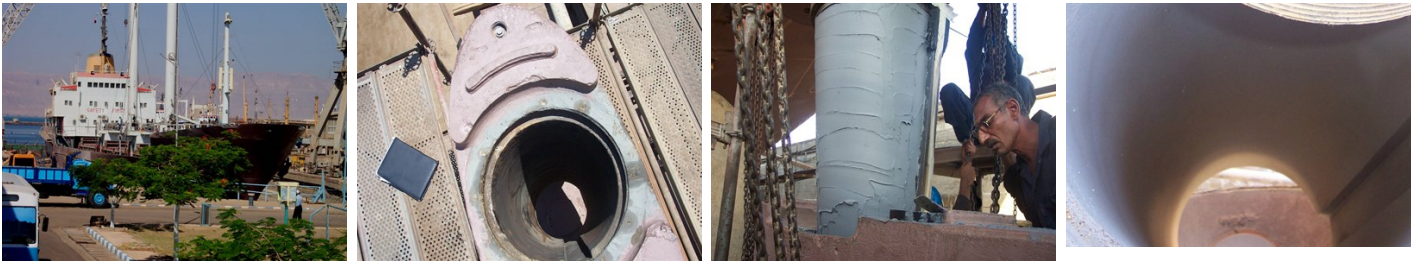
Photograph Descriptions

Pintle housing had become oversized due to corrosion.

- * General view of the ship ,
- * The oversized pintle housing ,
- * After applying Belzona Release Agent to the pintle, Belzona® 1121 was applied to the pintle ,
- * Pintle housing was perfectly repaired ,

Belzona was used to allow an in-situ repair with minimum repair downtime. The other option of welding and machining would be difficult to accomplish, potentially dangerous due to heat distortion, and significantly more expensive.
