Make Hay While the Sun Shines

ID: 576

Damaged obsolete U.S. Royal 5.50-16 implement tread tire from J.I. Case 140w hay baler.

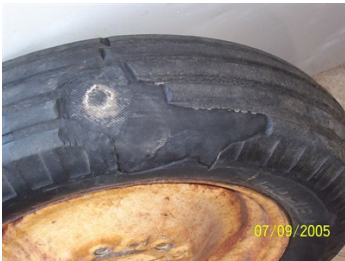
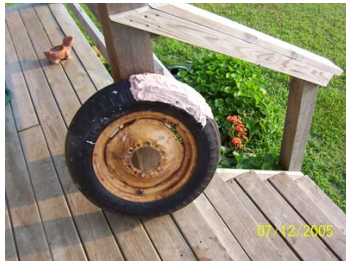
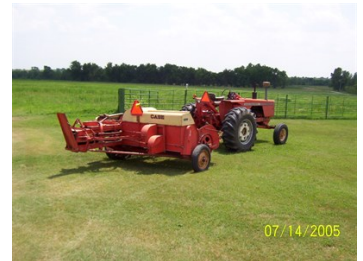
Photograph Descriptions

Tire was damaged but cords still in good condition. No replacement available.

- * Damaged tire. ,
- * All loose rubber removed from tire. ,
- * Release agent was applied to a mold. Belzona® 2211 was applied to the tire and mold. ,
- * The tire repaired. ,

Application was carried out in accordance with a modified version of Belzona® Know-How System Leaflet MPT-10.
