Make Hay While the Sun Shines

ID: 576

Industry: *General Industry*
Application: *MPT-Mechanical Power Transmission*

Damaged obsolete U.S. Royal 5.50-16 implement tread tire from J.I. Case 140w hay baler.

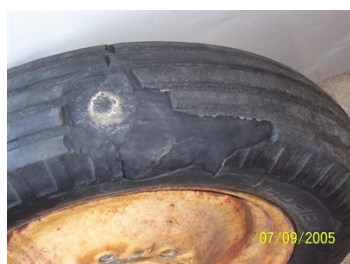
Tire was damaged but cords still in good condition. No replacement available.

- * Damaged tire. ,
- * All loose rubber removed from tire. ,
- * Release agent was applied to a mold. Belzona® 2211 was applied to the tire and mold. ,
- * The tire repaired. ,

Application was carried out in accordance with a modified version of Belzona® Know-How System Leaflet MPT-10.
