BELZONA GIVES NEW LIFE TO GROCERY STORE FLOOR

Industry: Buildings & Structures
Application: FPA-Floor Problem Areas
Substrate: Concrete
Products: * Belzona 4111 (Magma-Quartz),
* Belzona 4911 (Magma TX Conditioner),

Customer Location: Grocery Store, Northern Texas, USA
Application Date: 2014

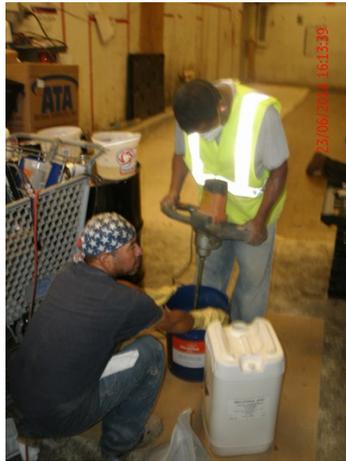
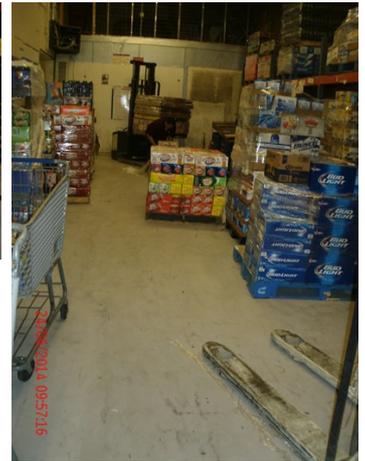
Receiving floor at a grocery store was so rough that groceries were falling off the pallets.

- * Preparation completed and conditioned with Belzona 4911 ,
- * Mixing station ,
- * Application in progress ,
- * Completed application ,

Damaged floor

The floor was ground and conditioned with Belzona 4911 to prepare the surface for application. Then, 1/4 of Belzona 4111 was applied to level the floor.

The application was started in the evening and ready for service by the first delivery. A previous product had failed within months.
