LEAKING VENT SEALED WITH BELZONA

ID: 5773

Application: *RPA-Roof Problem Areas*

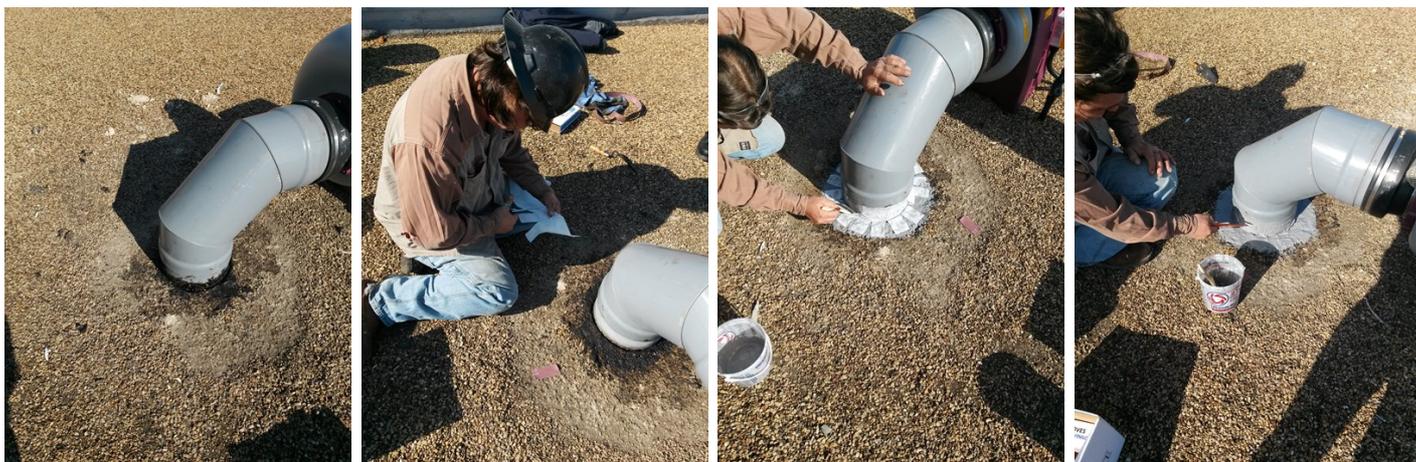
A roof vent was installed, but ponding water leaked through the black mastic roof sealer.

- * Newly installed vent ,
- * Prepared area ,
- * Fabric being applied ,
- * Completed application ,

The application was carried out in accordance with Belzona Know-How System Leaflet RPA-1. The surface was prepared by scraping away the gravel. Then, Belzona 3121 was applied with fabric to seal the duct.

The roof was leaking in the production area from the vent. It was sealed the day before it rained, saving a production shutdown.
