BELZONA REBUILDS OVERSIZED HOUSING

ID: 5774

Industry: *Marine*
Application: *SOS-Ships and Offshore Structures*

Customer Location: *Dockyard, Croatia*
Application Date: *November, 2015*

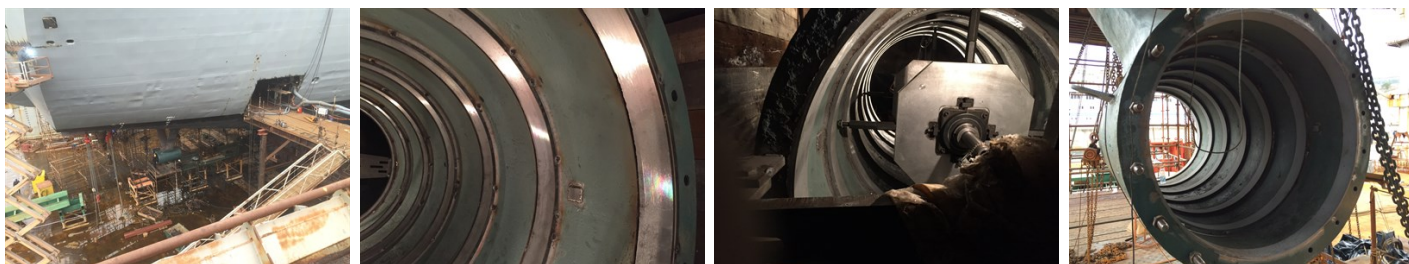
Photograph Descriptions

Support surface for bearing sleeves of tail shaft were oversized due to erosion and corrosion.

- * General view of ship in drydock ,
- * Prepared surfaces ,
- * Machining down to profile ,
- * Completed application ,

The application was carried out using a modified Belzona Know-How System Leaflet SOS-9. The surfaces were rebuilt then machined to size.
