BONDING SUPPORT PADS WITH BELZONA

ID: 578

Industry: Oil & Gas
Application: VPF-Valves, Pipes and Fittings
Substrate: Steel
Products: * Belzona® 1121 (Super XL-Metal) ,

Customer Location: National Oil Co. - U.A.E.
Application Date: 2004

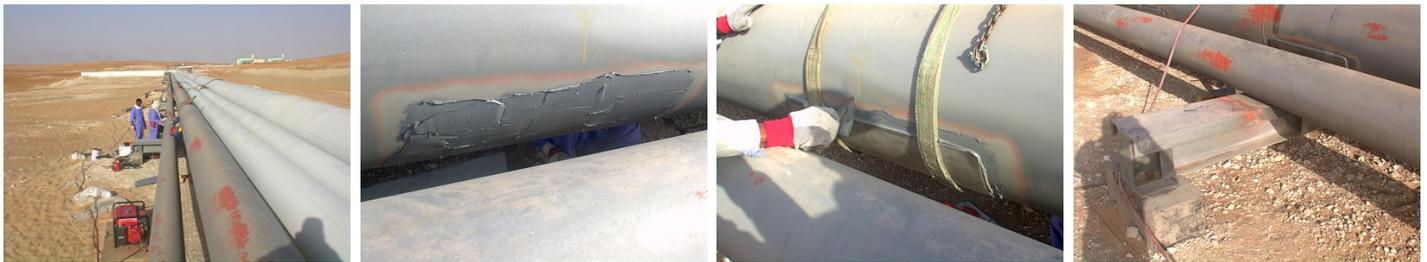
Photograph Descriptions

Corrosion and wear of pipes in area of supports caused by the constant thermal expansion and contraction.

- * The working environment ,
- * Bond area on pipeline grit blasted and Belzona® 1121 applied to wet out the surface ,
- * Wear pad strapped into place and exuded material being faired off ,
- * Completed application with pipe sat on support ,

Application was carried out in accordance with Belzona Know-How System Leaflet VPF-15.

Extended working life of Belzona® 1121 allows pads to be bonded effectively in the high desert temperatures. Over 300 pads have to be bonded to the pipeline.
