BELZONA MAIN INTAKE PUMPS

Customer Location: Nuclear Power Plant in Florida, U.S.A.
Application Date: August 1996

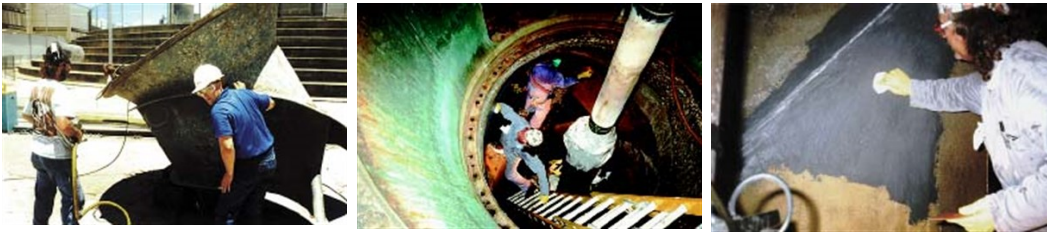
Photograph Descriptions

A hole in the diverter caused turbulence and erosion within the pump.

- * Hole in diverter is patched ,
- * Work commences ,
- * Erosion damage rebuilt with Belzona® 1311 (Ceramic R-Metal) ,

Application was carried out in accordance with Belzona Know-How Leaflets CEP-3, CEP-5, and CEP-6.

The hole in the diverter was causing a power drop from 100% to 80%. This was costing the power plant \$140,000 a day. Conventional replacement would have taken 45 days. The Belzona repair was accomplished in 2 days including cure time.
