## BELZONA REBUILDS OVERSIZE KEYWAY

Customer Location: *Water supply company, Bulgaria*

Application: *MPT-Mechanical Power Transmission*

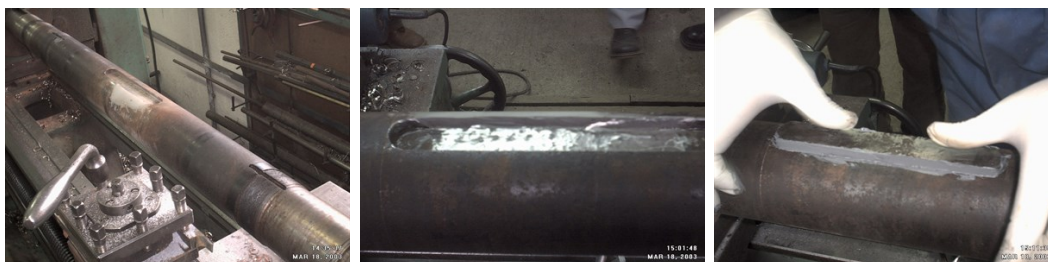
### Photograph Descriptions

*Broken edge of the keyway seat. Insufficient contact area for the load transmission.*

\* The worn keyway Surface prepared Keyway being bedded into Belzona ,

Shaft from double suction split case centrifugal pump.

The application was carried out in accordance with Belzona Know-How System Leaflet MPT-4.

Belzona repair provided a low cost alternative to welding and re-machining with a fast return to service. The repair was still in service when checked (June 2007).
