# BELZONA TECHNOLOGY REPAIRS SHAFT

ID: 5804

Industry: *General Industry*  
Application: *MPT-Mechanical Power Transmission*

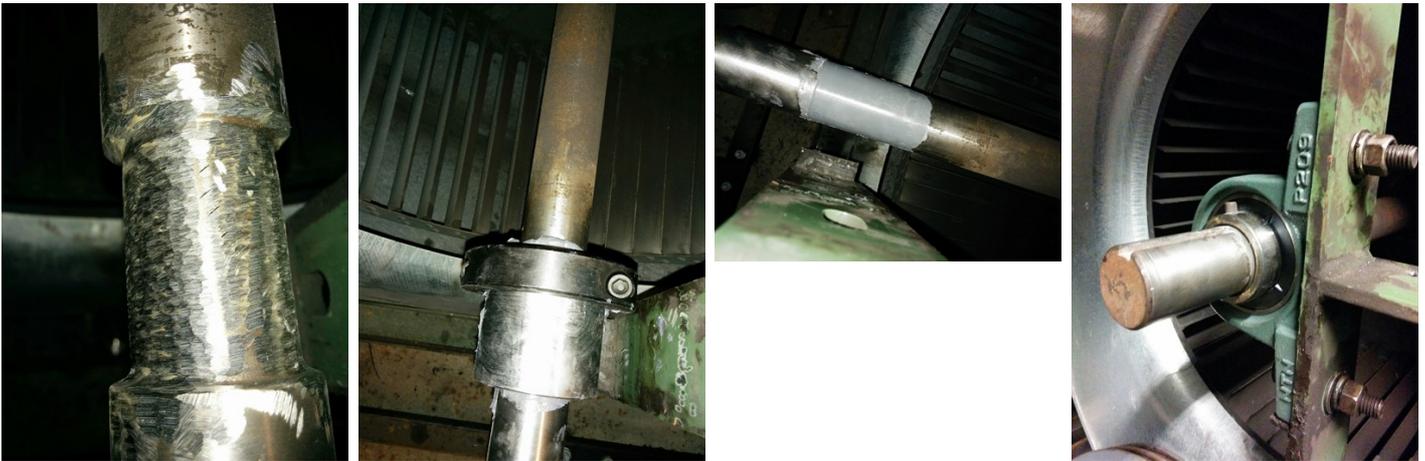
*Poor lubrication and wear to the bearing caused it to gouge out material from the pulley shaft.*

- \* Preparation complete ,
- \* Application in progress ,
- \* Completed application ,
- \* Shaft back in service ,

The application was carried out in accordance with Belzona Know-How System Leaflet MPT-2 for rebuilding damaged shafts using forming techniques. The area was prepared for application using a grinder to roughen the surface. Belzona 9411 was applied to the former in accordance with appropriate Belzona Instructions For Use. Belzona 1212 was applied onto the shaft and former, then the

former was attached to the shaft, allowing Belzona 1212 to cure. Once Belzona 1212 cured, the former was removed and the application was completed by removing trim lines and excess material.
