# BELZONA BRINGS BACK LIFE TO 20 YEAR OLD TRANSFORMER

Industry: Power  
Application: TCC-Tanks and Chemical Containment Areas  
Substrate: Steel  
Products: \* Belzona 1161 (Super UW-Metal) ,  
\* Belzona 9341 (Reinforcement Tape) ,

Customer Location: Whitby, ON, Canada  
Application Date: July 2015

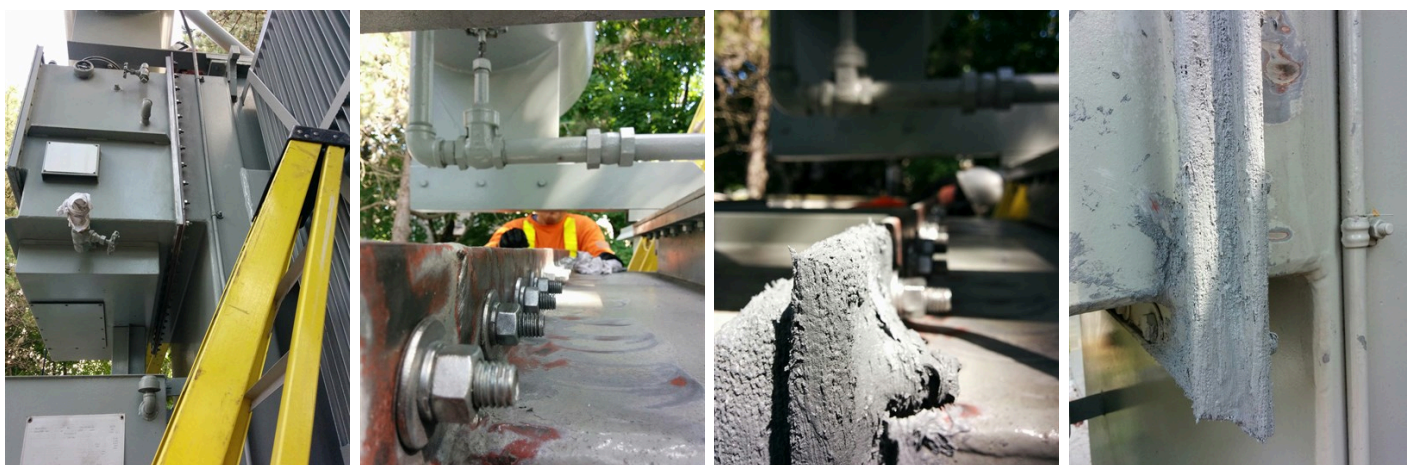
The transformer was temporarily drained and shut down due to leaking oil contaminating the surrounding ground soil, which was a safety and environmental concern.

- \* View of the transformer ,
- \* Preparation in progress ,
- \* Close up view of application ,
- \* Completed application ,

The application was carried out in accordance with Belzona Know-How System Leaflet TCC-1 for sealing crack, porous welds, bolted and riveted joints on tanks. The surface was prepared using a grinder and wire wheels electric hand tool. Belzona 1161 and Belzona 9341 was applied to the area in accordance with Belzona Instructions For Use.
