# BELZONA REPAIRS AND PROTECTS SEA WATER CIRCULATION PUMP

Customer Location: Power plant, Fujian, China

The casing of sea water circulation pump

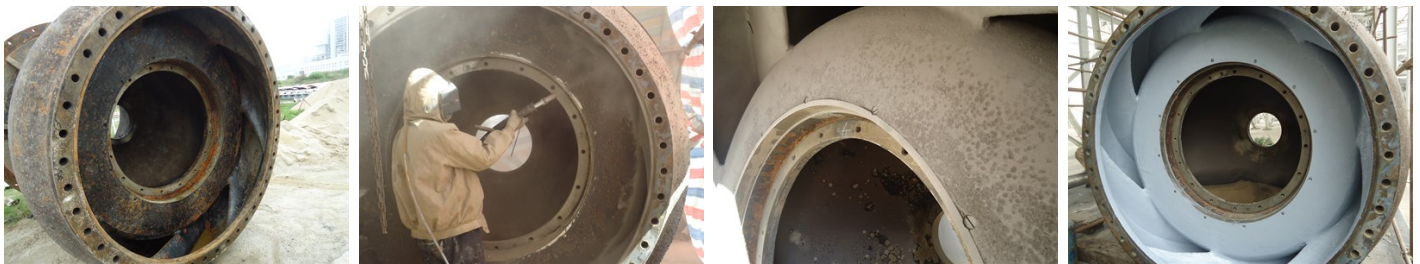
*After years of operation, the casing was badly eroded and damaged by the sea water*

- \* Overview of the circulation pump ,
- \* Surface preparation by grit blasting ,
- \* Close-up view of the damaged area after the blasting ,
- \* Completed application ,

The application was carried out in accordance with Belzona Know-How System Leaflets CEP-1 & CEP-3. Holes were repaired with Belzona 1311. The high spots were ground down to smooth the surface and Belzona 1341 then applied.
