# BELZONA STOPS TANK LEAK

ID: 5809

**Customer Location:** Power Plant, Northern Texas, USA  
**Application Date:** 2014

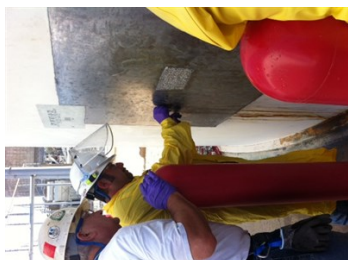
Emergency water tank was thin walled and leaking. Welding produced more leaks. The tank could not be taken out of service. Thin wall and leaks needed to be fixed while the tank was full.

The application was carried out in accordance with Belzona Know-How System Leaflet TCC-1. The tank was blasted, which revealed three active leaks. The leaks were stopped with Belzona 1291. Then the entire area was coated with a fully reinforced Belzona 1111 with Belzona 9311.
