# BELZONA SEALS ASH TANK ROOF

Industry: Power  
 Application: RPA-Roof Problem Areas  
 Substrate: Carbon steel  
 Products: \* Belzona 2211 (MP Hi-Build Elastomer) ,  
 \* Belzona 3111 (Flexible Membrane) ,

Customer Location: Power plant, Guangxi, China  
 Application Date: October 2006

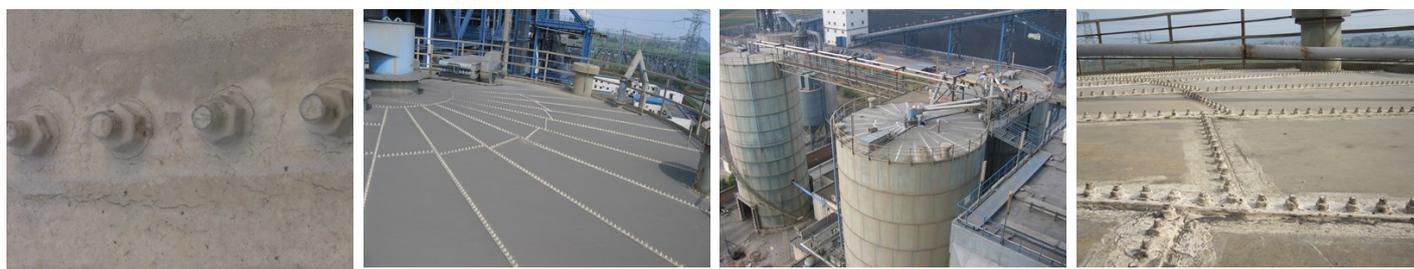
After years of service, the steel plates had started leaking. Two other coatings were applied but both failed.

- \* The previous coating failed within 1 year. The cracks in the joint caused leaking ,
- \* The repair work was completed with Belzona solution ,
- \* Overview of the completed application ,
- \* After 7 years, the repair still in perfect condition ,

Application was carried out in accordance with Belzona Know-How System Leaflet FPA-6, RPA-1 and 6. The joints were sealed with Belzona 2211, before applying a fully reinforced Belzona 3111 Flexible Membrane system.
