SPALLED STEPS NO LONGER A SAFETY HAZARD WITH BELZONA REPAIR

ID: 5814

Customer Location: Waterloo, ON, Canada
Application Date: September 2014

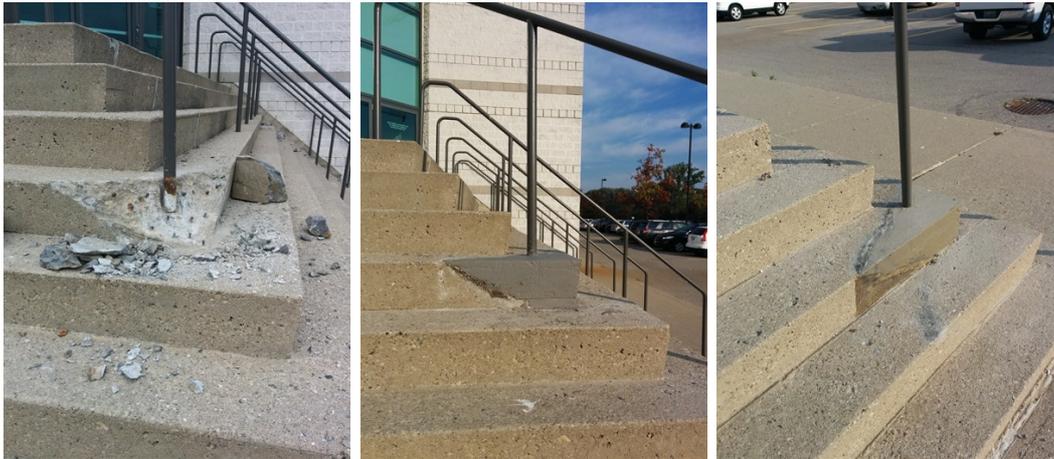
Photograph Descriptions

The stairs had spalled due to environmental freeze and thaw effect.

- * Prior to application ,
- * Completed application ,
- * Completed application ,

The application was carried out in accordance with Belzona Know-How System Leaflet FPA-10 for fixing or securing anchor bolts or hand rails. The surface was prepared using a grinder and the surface was brushed to remove any loose concrete. Belzona 4911 was applied to the area using a stiff bristle brush. Belzona 4131 was applied directly onto the conditioned surface in accordance with Belzona Instructions For Use.
