# PIPE ELBOW REPAIRED AND PROTECTED WITH BELZONA

ID: 5815

Industry: General Industry  
Application: SHM-Solids Handling Machinery

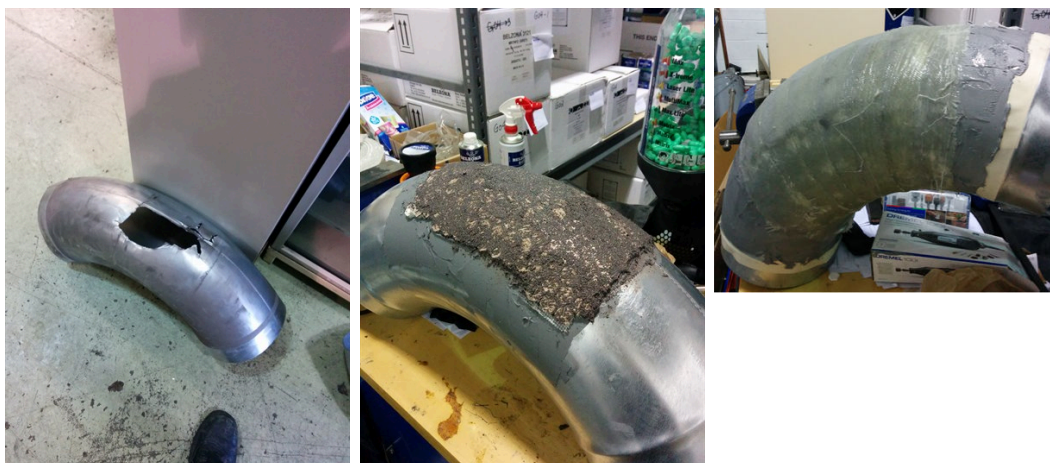
The blast material going through the pipe wore a hole to the side of the pipe elbow.

- \* Prior to application ,
- \* Application in progress ,
- \* Completed application ,

The application was carried out in accordance with Belzona Know-How System leaflet SHM-8 for rebuilding worn pipe elbows. Belzona 9811 was bonded to the outside of the elbow with Belzona 1111. Then, Belzona 9811 was grouted using Belzona 1812 to

fill in all the gaps with the abrasion resistant material. Then, Belzona 9381 was wrapped around the elbow wetted out with Belzona 4151.
