HOLDING PANS IN CHILLER UNITS NO LONGER CORRODING WITH BELZONA REPAIR

ID: 5817

Industry: Heating, Ventilation & Air Conditioning
Application: TCC-Tanks and Chemical Containment Areas

Customer Location: Waterloo, ON, Canada
Application Date: May 2015

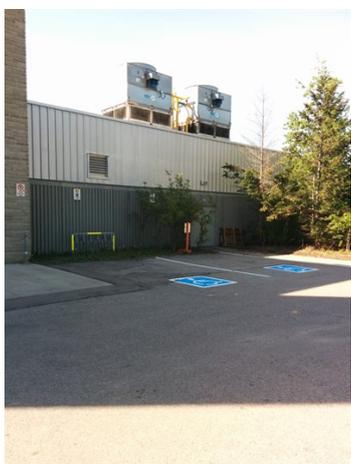
The holding pans in both of the chiller units had corroded and were leaking onto the roof.

- * View of the holding pans ,
- * Application in progress ,
- * Application in progress ,
- * Completed application ,

The application was carried out in accordance with Belzona Know-How System Leaflet TCC-15 for sealing and protecting containment areas. The unit was prepared using a grit blaster to remove all scale and corrosion. Belzona 1111 was applied to repair

the holes and seal all the edges. Belzona 5811 was applied to the holding pans in accordance with Belzona Instructions For Use.
