# HOLDING PANS IN CHILLER UNITS NO LONGER CORRODING WITH BELZONA REPAIR

Industry: Heating, Ventilation & Air Conditioning  
Application: TCC-Tanks and Chemical Containment Areas  
Substrate: Steel  
Products: \* Belzona 1111 (Super Metal) ,  
\* Belzona 5811 (Immersion Grade) ,

Customer Location: Waterloo, ON, Canada  
Application Date: May 2015

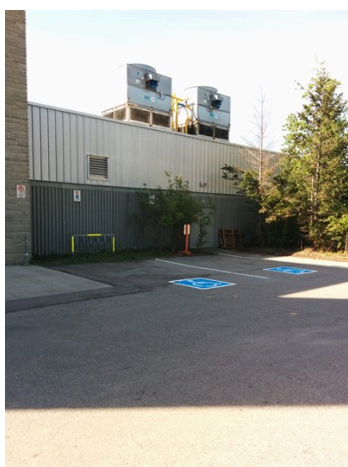
The holding pans in both of the chiller units had corroded and were leaking onto the roof.

- \* View of the holding pans ,
- \* Application in progress ,
- \* Application in progress ,
- \* Completed application ,

The application was carried out in accordance with Belzona Know-How System Leaflet TCC-15 for sealing and protecting containment areas. The unit was prepared using a grit blaster to remove all scale and corrosion. Belzona 1111 was applied to repair

the holes and seal all the edges. Belzona 5811 was applied to the holding pans in accordance with Belzona Instructions For Use.
