BELZONA REPAIR OF TWO STAGE PUMP

Industry: Power
Application: CEP-Centrifugal Pumps
Substrate: Cast iron
Products: * Belzona® 1111 (Super Metal) ,
* Belzona® 1311 (Ceramic R-Metal) ,
* Belzona® 1321 (Ceramic S-Metal) ,

2 Stage Centrifugal Pump (Model 3B200x2)

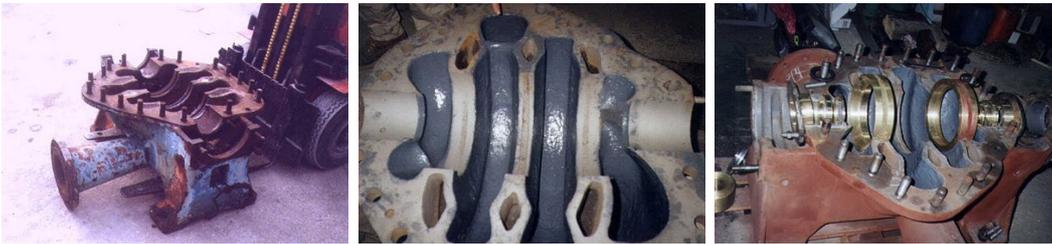
Erosion, wear and corrosion of sealing elements and pump casing.

- * Pump surface before preparation ,
- * Belzona® 1321 applied to grit blasted surface ,
- * Refurbishing seal ring seats and bearing seats by forming ,

Application procedures were carried out in accordance with Belzona Know-How System Leaflets CEP-1 and CEP-2.

Pump refurbished without machining and has saved time and money over traditional repairs or replacement.
