BELZONA REPAIRS HOLE ON SCUM TANK

ID: 5827

Application Situation

Scum tank at a water pollution control plant.

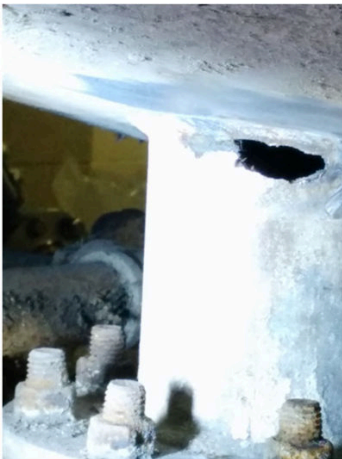
Hole caused by corrosion.

- * Prior to application ,
- * Preparation in progress ,
- * Application in progress ,
- * Completed application ,
