# BELZONA REPAIRS HOLE ON SCUM TANK

## Application Situation

Scum tank at a water pollution control plant.

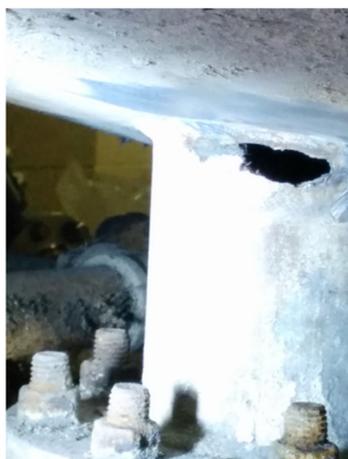
*Hole caused by corrosion.*

- \* Prior to application ,
- \* Preparation in progress ,
- \* Application in progress ,
- \* Completed application ,
