CONVENIENT BELZONA CONVEYOR BELT REPAIR

ID: 583

Application: SHM-Solids Handling Machinery

Customer Location: Power Industry, Bulgaria

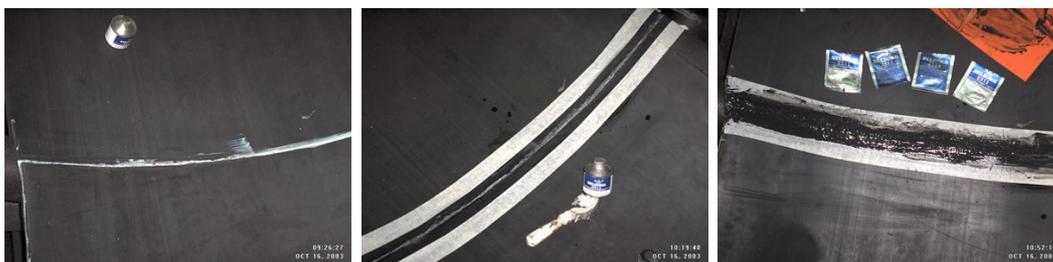
Photograph Descriptions

Joint failing due to moisture.

- * Original joint ,
- * Repair area masked off and conditioned ,
- * Completed application ,

Previously vulcanized joints in coal conveyor utilizing Tip Top.

The application was carried out in accordance with Belzona Know-How System Leaflet SHM-6.

The Belzona repair minimizes down-time and is accomplished without specialist vulcanizing equipment. this application lasted in excess of three years and Belzona is routinely used at the facility for belt repairs.
