# CONVENIENT BELZONA CONVEYOR BELT REPAIR

ID: 583

Application: *SHM-Solids Handling Machinery*

Customer Location: *Power Industry, Bulgaria*

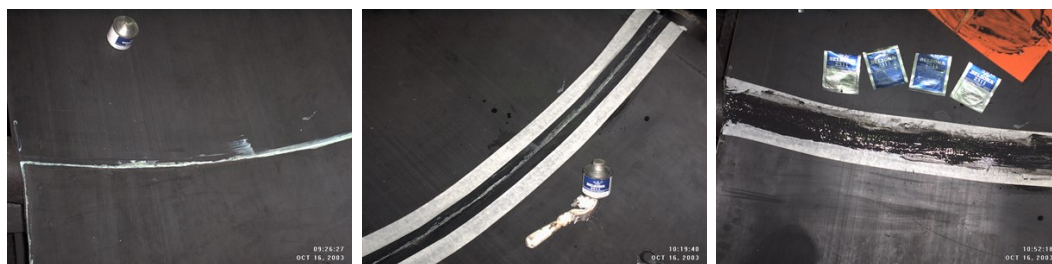
*Joint failing due to moisture.*

- \* Original joint ,
- \* Repair area masked off and conditioned ,
- \* Completed application ,

Previously vulcanized joints in coal conveyor utilizing Tip Top.

The application was carried out in accordance with Belzona Know-How System Leaflet SHM-6.

The Belzona repair minimizes down-time and is accomplished without specialist vulcanizing equipment. this application lasted in excess of three years and Belzona is routinely used at the facility for belt repairs.
