BELZONA REPAIRS HOLE IN PROCESS KETTLE

ID: 5839

Process kettle at a food production plant.

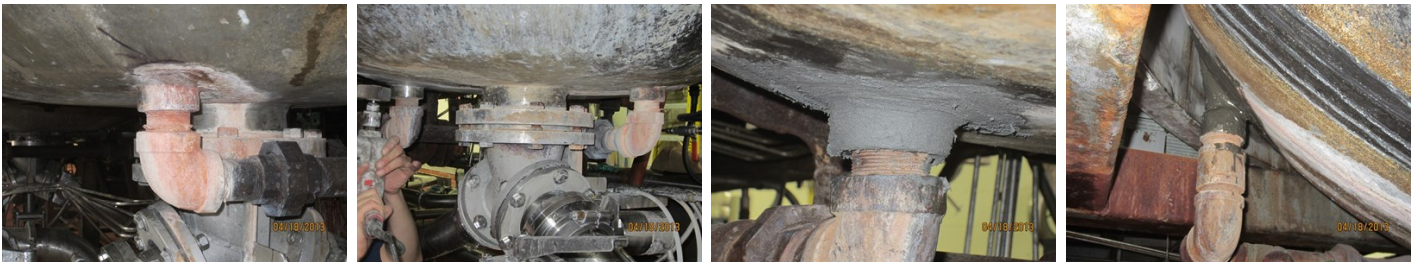
Photograph Descriptions

A hole in the weld seam due to corrosion.

- * Prior to application ,
- * Surface preparation in process ,
- * Completed application ,
- * Completed application ,

The application was carried out in accordance with Belzona Know-How System Leaflet VPF-1 for rebuilding erosion-corrosion damage. The surface was prepared by using a hand grinder. Belzona 9111 was used to remove all of the dirt and grease from the surface. A layer of Belzona 1511 was applied to the area and Belzona 9341 was wrapped over the layer. Then, Belzona 1511 was applied once again in accordance with the Belzona Instructions For Use.
