# BELZONA REPAIRS FLANGE OF OFFSHORE PLATFORM

Industry: Oil & Gas  
Application: VPF-Valves, Pipes and Fittings  
Substrate: Carbon Steel  
Products: \* Belzona 1111 (Super Metal) ,  
\* Belzona 9411 (Release Agent) ,  
\* Belzona 9111 (Cleaner Degreaser) ,

Customer Location: Gulf of Mexico, USA  
Application Date: August 2015

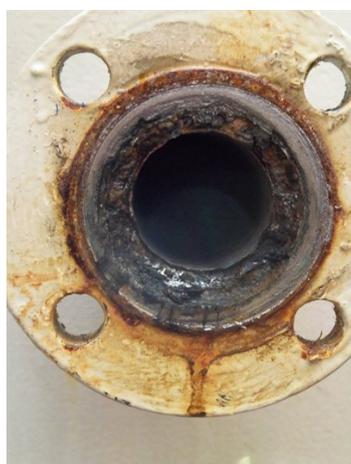
- \* Original condition ,
- \* Ready for bolting together ,
- \* Flange former in place ,
- \* Completed application ,

An offshore platform was experiencing a leak in a nozzle flanged connection on a Deaerator Tower. The corrosion was related to high concentration of an oxygen scavenger chemical.
