BELZONA REPAIRS FLANGE OF OFFSHORE PLATFORM

Customer Location: Gulf of Mexico, USA
Application Date: August 2015

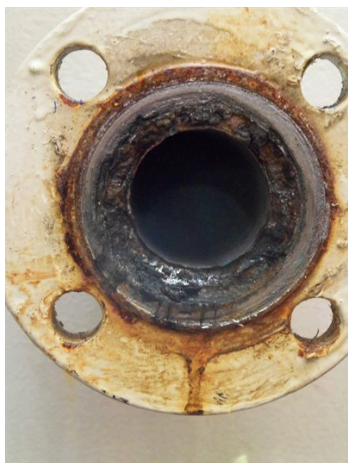
- * Original condition ,
- * Ready for bolting together ,
- * Flange former in place ,
- * Completed application ,

An offshore platform was experiencing a leak in a nozzle flanged connection on a Deaerator Tower. The corrosion was related to high concentration of an oxygen scavenger chemical.
