# BELZONA FULLY SEALS FLANGE BETWEEN KAPLAN TURBINE AND SPIRAL CASING

Customer Location: Hydropower Station, Aschbach, Austria

Application Date: July/August 2010

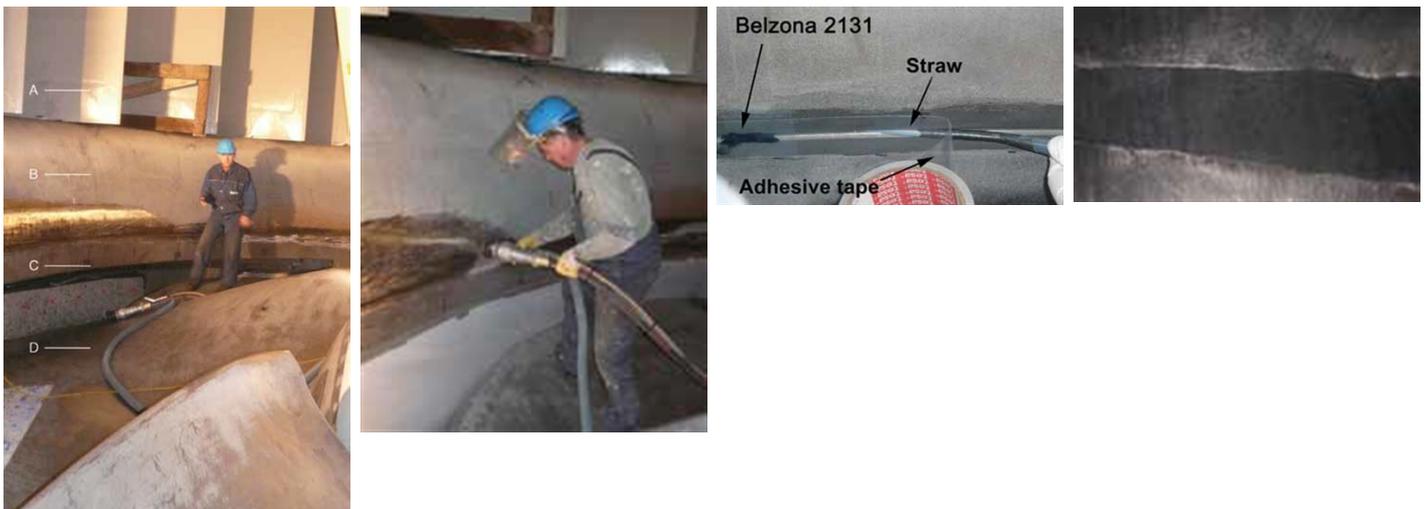
A new larger turbine runner, which has recently been built to increase the turbine output, required the installation of a new turbine casing that required welding. The heat generated from this process caused the turbine casing to become distorted and a circumferential gap of between 2.8 mm to 4.6 mm appeared between the two mating flanges.

- \* View of the Kaplan Turbine; A) stay vanes, B) spiral casing, C) circumferential gap, D) turbine runner output, 85 MW ,
- \* Surface preparation with the dust-free vacu-blast system ,
- \* Tape used to prevent overflow and to ensure gap was fully injected with Belzona 2131 ,
- \* Completed repair with Belzona 2131 on inside section of gap ,

The surface in and around the gap was prepared by grit blasting to ensure a minimum profile depth of 90 microns. The next step was to insert a foam backer rod into the gap to prevent Belzona 2131 from flowing into the outer section. In order to achieve the best adhesion possible, the surfaces had to be pre-treated with Belzona 2941. The injection nozzle was elongated with a flexible straw to ensure that Belzona 2131 could be injected into even the smallest area. The injection method was carried out and after cure, which in this case needed three-and-a-half days, the tape was removed and Belzona 2131 was faired level to the metal surface. The outer gap was then prepared for the injection of Belzona 1321. 96 bolt holes were injected with Belzona 1321 and the edge was then sealed with Belzona 1111 to ensure no overflow would occur. The bolt was treated with Belzona 9411 which ensured that the bolt could be removed easily after curing. Once fully cured, the release agent bolts were replaced by the originals and the flanges could be mated together without unnecessary stressing and the casing joint was now fully sealed.
