# BELZONA REPAIRS CRUSHER SHAFT

ID: 5847

Customer Location: Cement plant, Northern Cape, South Africa

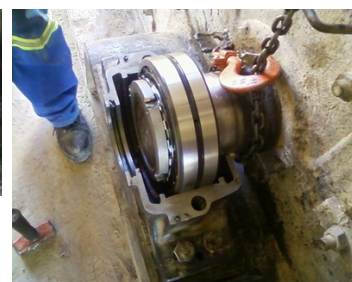
The hammer crusher shaft was worn on the taper bearing location.

\* 1. Shaft being prepared. 2. Roughened shaft being degreased with Belzona 9111 3. Belzona 1111 applied to shaft before former located 4. New bearing installed on the shaft ,

Application was carried out in accordance with Belzona System Leaflet MPT-2. A former was used to accurately rebuild bearing location on the shaft.
