# COURTHOUSE PLAZA STAIRS REPAIRED WITH BELZONA

**Industry:** Buildings & Structures  
**Application:** FPA-Floor Problem Areas  
**Substrate:** Concrete Stairs  
**Products:** \* Belzona 4111 (Magma-Quartz),  
\* Belzona 4911 (Magma TX Conditioner),

**Customer Location:** County Courthouse, Vermont, USA  
**Application Date:** 2006

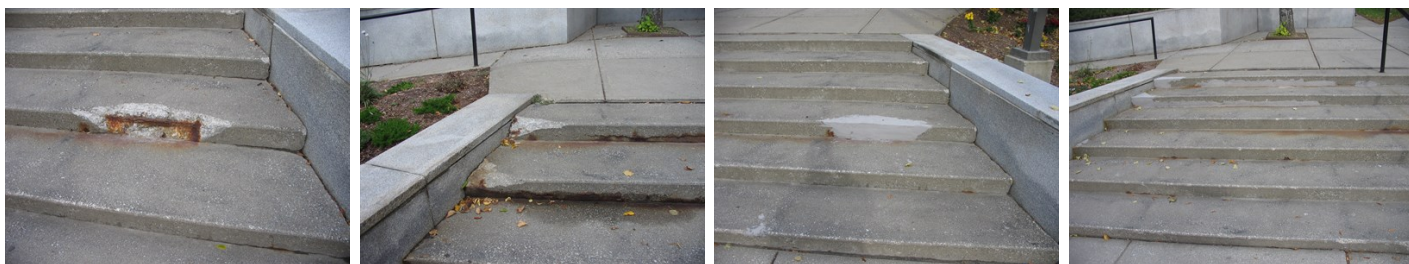
Concrete loss and creation of trip hazards.

- \* View of damaged step ,
- \* Other visible damages to steps ,
- \* Completed repair ,
- \* Overview of completed repair ,

Main entryway plaza steps from the street and into the courthouse had several unsightly spalls and cracks in the concrete caused by winter freeze thaw and use of chemical deicers.

The application was carried out in accordance with Belzona Know-How System Leaflet FPA-5. The surface was prepared by hand cleaning with power tools.

One bucket of Belzona 4111 and an afternoon of labor saved the courthouse the inconvenience of closing the stairs for 3 - 5 days that would have been required by the traditional mortar repairs. Additionally, it was a lot less expensive utilizing in house labor.
