# BELZONA REPAIR TO KING PIN BUSH HOUSING

ID: 588

Front end loader king pin connection

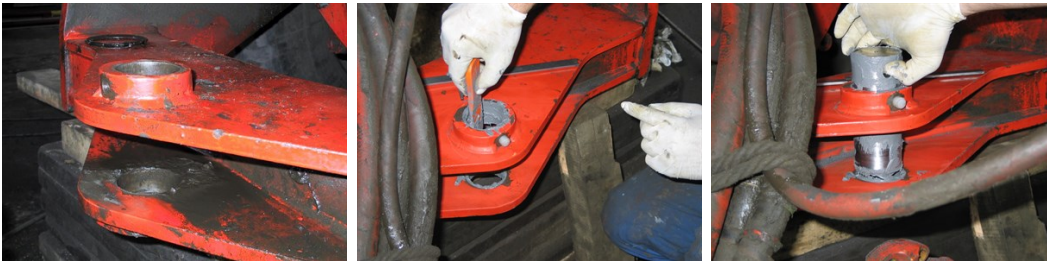
*Wear of the seats leading to increased clearance*

\* View of the damaged connection. , \* Belzona® 1111 applied on the prepared housing surface. , \* The pin coated with release agent was used to form the housing. ,

Application was carried out in accordance with Belzona Know-How System Leaflet MPT-8.

Belzona returned the equipment to service in one day. The Belzona repair was simple to carry out and saved machining.
