# BELZONA SEALS VALLEY GUTTERS

ID: 5887

Customer Location: *Manufacturing Plant, Scotland*  
Application Date: *October 2014*

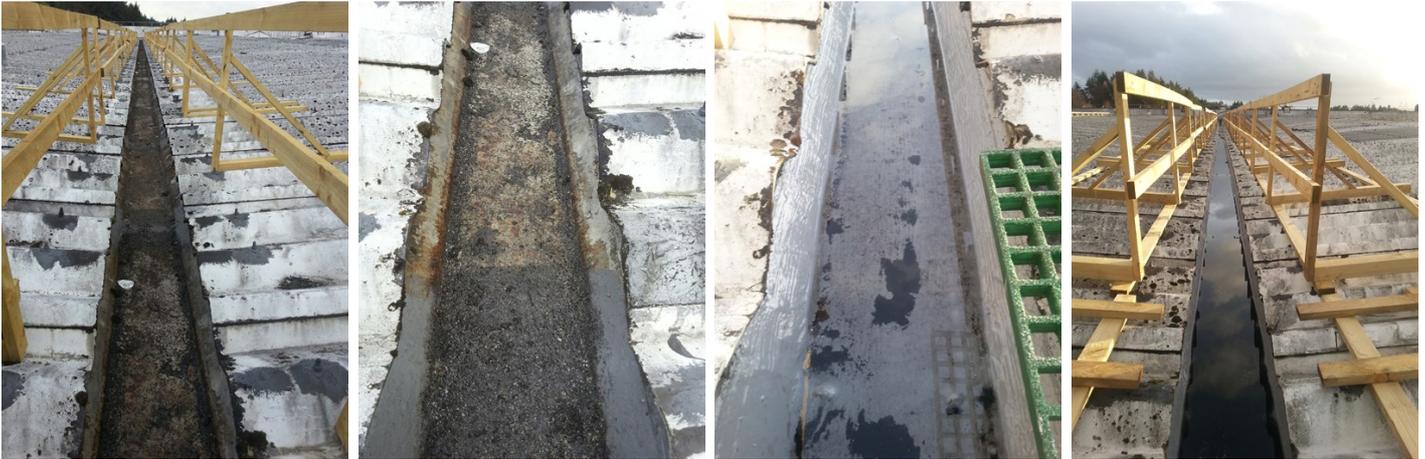
- \* Length of gutters before surface preparation ,
- \* Section of gutter showing build up of dirt & corrosion ,
- \* Length of gutter coated ,
- \* Standing water still an issue but the gutter is now leak free ,

Several valley gutters constructed from cast steel had begun to leak from the joints. These leaks were causing damage to the stored materials below.

The application was carried out in accordance with Belzona Know-How System Leaflet RPA-6.

Belzona 3131, a liquid applied membrane, allowed the applicators to coat the existing substrate without removing large sections of

the roof. The Belzona 3131 system is flexible, which has allowed a long lasting repair over the problem joints where competitor materials had failed.
