# BELZONA REPAIRS TANK NOZZLE

ID: 5892

**Customer Location:** Zinc Producer, North Carolina, USA  
**Application Date:** July 2015

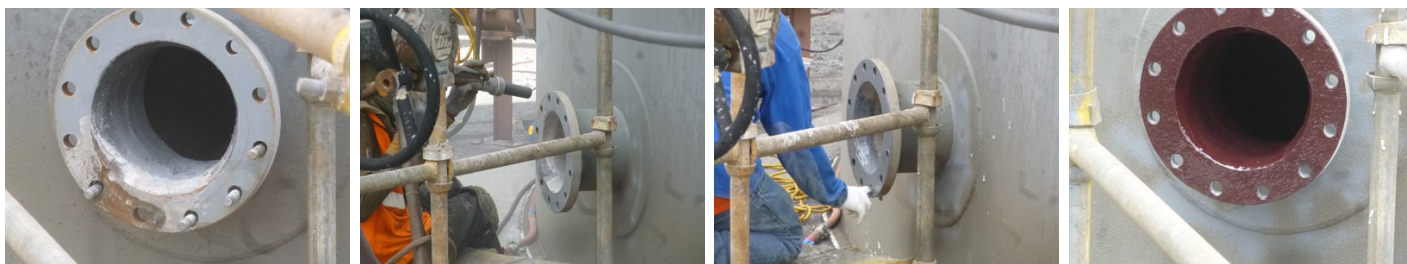
*The original coating inside the tank nozzle failed due to acid erosion. Sulfuric acid began leaking into the containment area.*

- \* Damaged tank nozzle ,
- \* Blast work being carried out on tank nozzle ,
- \* Rebuilding the flange of the nozzle with Belzona 4301 ,
- \* Completed nozzle with Belzona 4311 coating ,

The tank nozzle flange and inside neck area was blasted to prepare its surface for the Belzona coating. Belzona 4301 was used to build the tank nozzle flange back up to its original shape. Two coats of Belzona 4311 were used to coat the flange and the interior of the tank nozzle.
