BELZONA SUPERWRAP II UPDATES RISER

ID: 5894

Industry: Oil & Gas
Application: SOS-Ships and Offshore Structures

Customer Location: Gulf of Mexico, USA
Application Date: September 2015

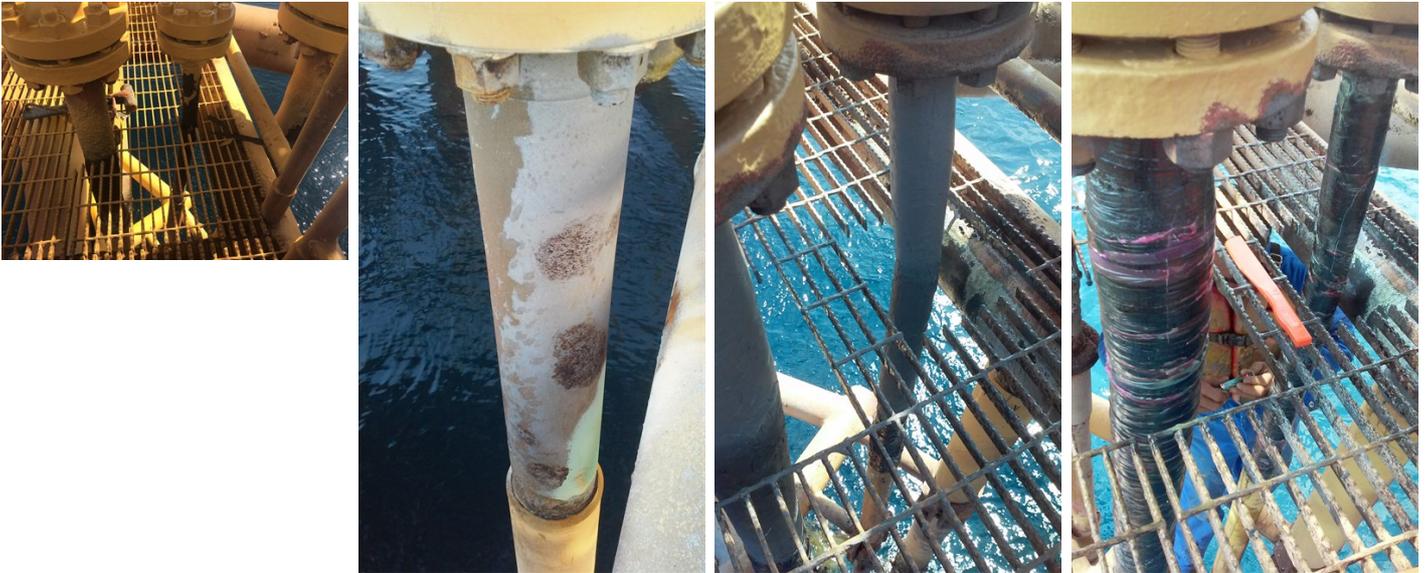
Photograph Descriptions

External corrosion was creating thin wall defective areas with potential loss of structural integrity. The asset owner wanted to restore the integrity of the pipe wall by employing a compliant repair solution without downtime and loss of production.

- * Condition of riser before abrasive blast. ,
- * Riser during blast showing defect areas. ,
- * Rebuilding the substrate with Belzona 1121. ,
- * Completed application of Belzona SuperWrap II. ,

The repair area was abrasive blasted to achieve SSPC-SP 10 (Near White Metal) with an anchor profile of at least 3 mils. The surface was wiped clean with Belzona 9111 and maintained clean until commencement of the application. Belzona 1121 was used as a rebuilding material to fill pits and restore the original thickness of the wall. Belzona 9381 was saturated with Belzona 1982 and applied around the riser in 5 wraps (10 layers) in compliance with the engineered design. Then, Belzona 9382 was installed to consolidate the repair during the curing process. Once the system was cured, Belzona 9382 was released.
