# BELZONA SEALS AND PROTECTS RISER NEOPRENE SLEEVE INTERFACE

Industry: Oil & Gas  
Application: SOS-Ships and Offshore Structures

Customer Location: Gulf of Mexico, USA  
Application Date: September 2015

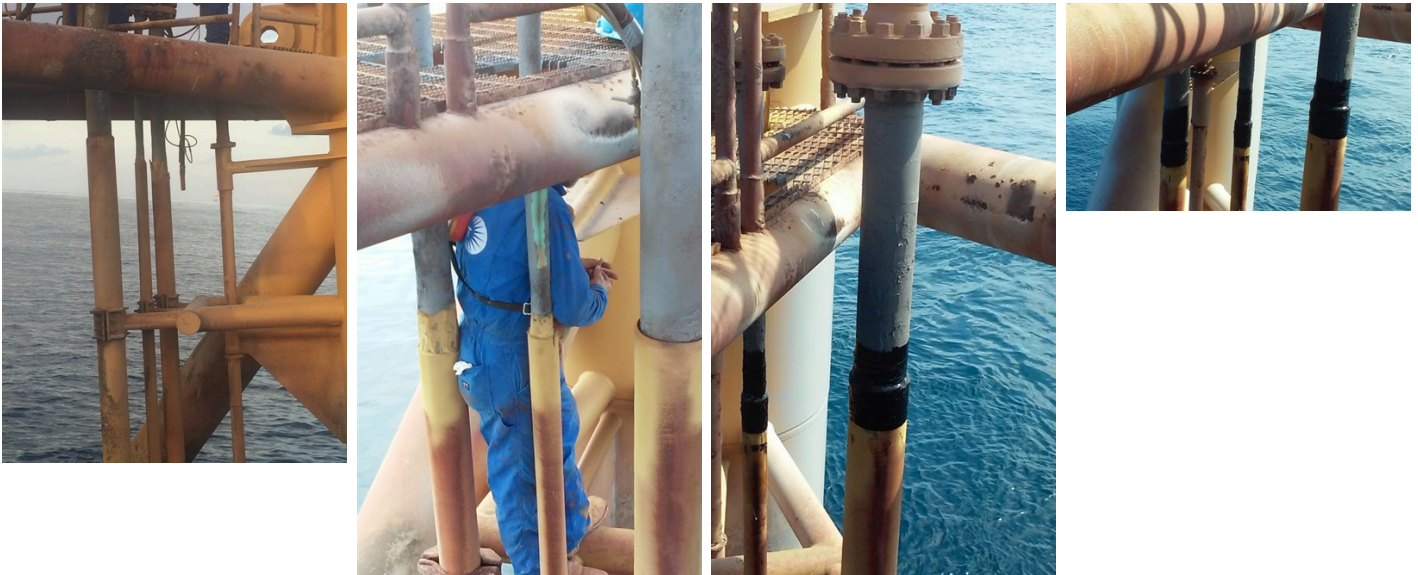
Poor adhesion of the neoprene sleeve on 3 risers allowed corrosion to develop between the sleeve and pipe wall, causing further deterioration of the riser. The asset owner required a suitable solution without downtime or loss of production.

- \* Condition of neoprene sleeve and riser interface. ,
- \* Neoprene sleeve cut back and surface preparation underway. ,
- \* First coat of Belzona 2131 with Belzona 9341 installed. ,
- \* Repair completed on 3 risers. ,

The application was carried out in accordance with a modified version of Belzona Know-How System Leaflet SOS-21. The neoprene sleeve was cut back to sound material and the surface was roughened. The metal surface was abrasive blasted and a skim coat of Belzona 1121 applied to fill pits. The repair area was treated with Belzona 2921 and allowed to dry. Belzona 2211 was installed at the sleeve and riser interface, and a taper was formed. Belzona 2131 was applied over the entire area and two layers of Belzona 9341 was embedded. A top coat of Belzona 2131 was then used to encapsulate the reinforcement.
