BELZONA SEALS AND PROTECTS RISER NEOPRENE SLEEVE INTERFACE

ID: 5895

Industry: Oil & Gas
Application: SOS-Ships and Offshore Structures

Customer Location: Gulf of Mexico, USA
Application Date: September 2015

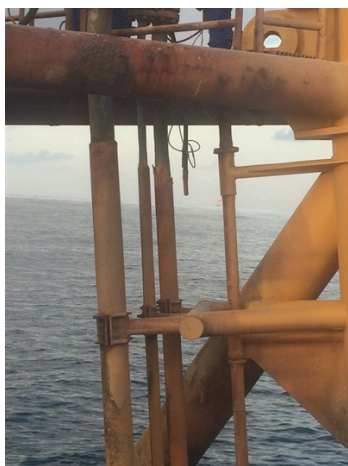
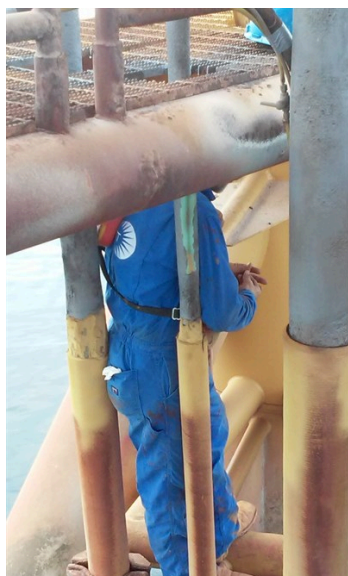
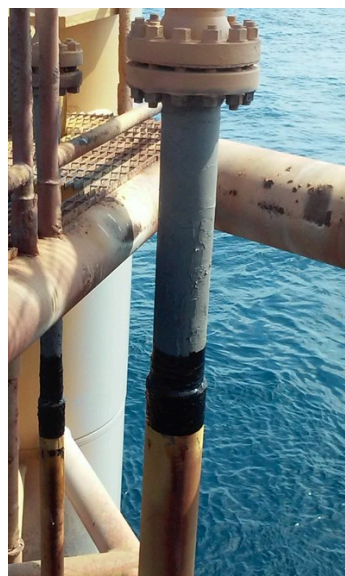
Photograph Descriptions

Poor adhesion of the neoprene sleeve on 3 risers allowed corrosion to develop between the sleeve and pipe wall, causing further deterioration of the riser. The asset owner required a suitable solution without downtime or loss of production.

- * Condition of neoprene sleeve and riser interface. ,
- * Neoprene sleeve cut back and surface preparation underway. ,
- * First coat of Belzona 2131 with Belzona 9341 installed. ,
- * Repair completed on 3 risers. ,

The application was carried out in accordance with a modified version of Belzona Know-How System Leaflet SOS-21. The neoprene sleeve was cut back to sound material and the surface was roughened. The metal surface was abrasive blasted and a skim coat of Belzona 1121 applied to fill pits. The repair area was treated with Belzona 2921 and allowed to dry. Belzona 2211 was installed at the sleeve and riser interface, and a taper was formed. Belzona 2131 was applied over the entire area and two layers of Belzona 9341 was embedded. A top coat of Belzona 2131 was then used to encapsulate the reinforcement.
