# REPAIRING COOLING TOWER SEAMS WITH BELZONA

ID: 5896

**Customer Location:** Hospital, North Carolina, USA  
**Application Date:** August 2015

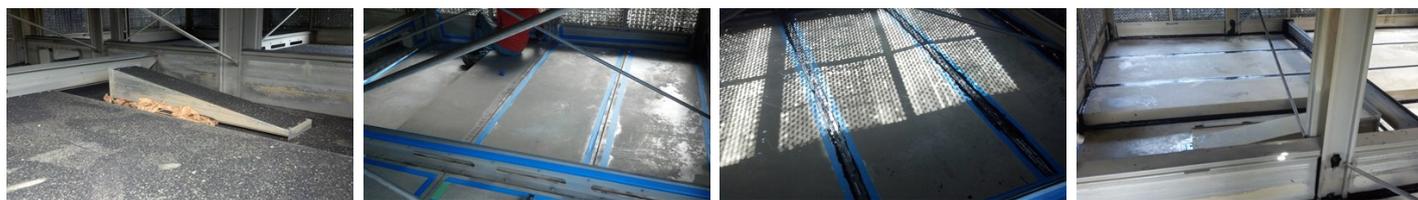
Towers were leaking around seams and protrusions.

- \* Blasting completed, prior to media removal ,
- \* Taping and conditioning all seams/protrusions ,
- \* First coat of Belzona 2131, embedding Belzona 9341 ,
- \* Completed application to towers ,

The application was carried out in accordance with Belzona Know-How System Leaflets HEX-6, HEX-13, TCC-12, FPA-6 and a modified version of FPA-7. The substrate was prepared via media blast with Black Beauty, cleaned, taped, and then conditioned with Belzona 2911. Once cured for ½ hour, a two-coat reinforced system of Belzona 2131 was utilized to create a polymer overlay over all assembly seams/joint. Bolt holes and other protrusions were top-dressed with a coating of Belzona 2131.
