# BELZONA AVOIDS LONGER DOWNTIME

ID: 5897

Industry: Power  
Application: FBC-Fans, Blowers and Compressors

Francis turbine cone.

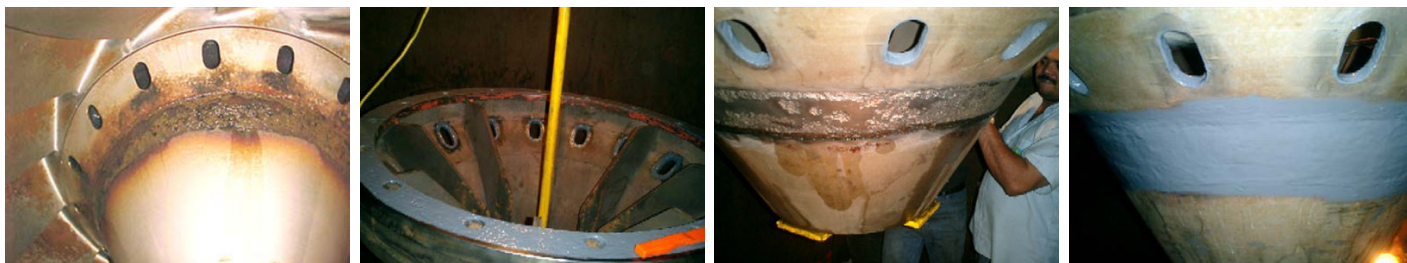
*Wear on the flange caused sealing problems and erosion/corrosion on the cone's border. Total disassembly of the unit would cause a longer downtime.*

- \* Damage on cone ,
- \* Damage on flange and application of Belzona 1321 ,
- \* Cleaning and refilling with Belzona 1311 ,
- \* Protected with Belzona 1321 ,

The application was carried out in accordance with Belzona Know-How System Leaflet FBC-5 and FBC-2.

The conventional solution required total disassembly of the unit with a long wait period and a high cost abroad, the Belzona solution was applied in situ and in 4 hours.
