# BELZONA AIRTIGHT CONTROL ROOM

**Industry:** Power  
**Application:** GSS-Gaskets, Seals and Shims  
**Substrate:** Concrete and metal  
**Products:** \* Belzona® 3211 (Lagseal Membrane) ,  
\* Belzona® 3921 (GSC Conditioner) ,  
\* Belzona® 2211 (MP Hi-Build Elastomer) ,

**Customer Location:** Power plant in Northern Illinois  
**Application Date:** February 1997

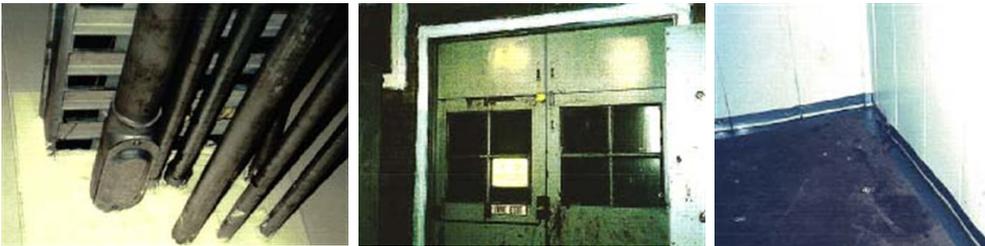
Building is not airtight, causing reduced pressure.

- \* All entry points made airtight with Belzona® 3211. ,
- \* Doorways of the building sealed. ,
- \* Belzona® 2211 used to seal where the metal wall meets the floor. ,

After sealing the building with the Belzona system, a 500% increase in pressurization was documented by the customer.
