BELZONA AIRTIGHT CONTROL ROOM

ID: 59

Customer Location: Power plant in Northern Illinois
Application Date: February 1997

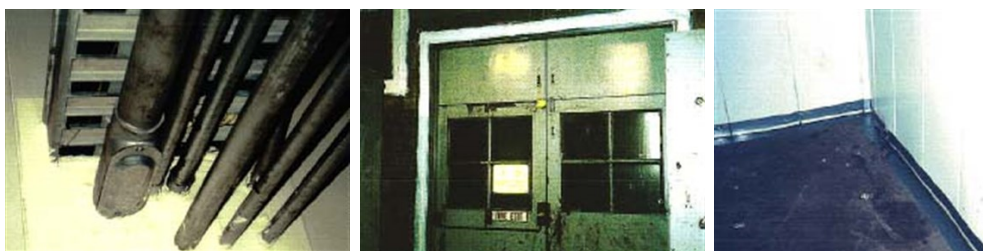
Photograph Descriptions

Building is not airtight, causing reduced pressure.

- * All entry points made airtight with Belzona® 3211. ,
- * Doorways of the building sealed. ,
- * Belzona® 2211 used to seal where the metal wall meets the floor. ,

The application was carried out in accordance with Belzona Know-How Leaflets GSS-3 and GSS-4.

After sealing the building with the Belzona system, a 500% increase in pressurization was documented by the customer.
