SHAFT JOURNAL OF STONE CRUSHER REPAIRED WITH BELZONA

ID: 590

Main shaft of primary stone crusher

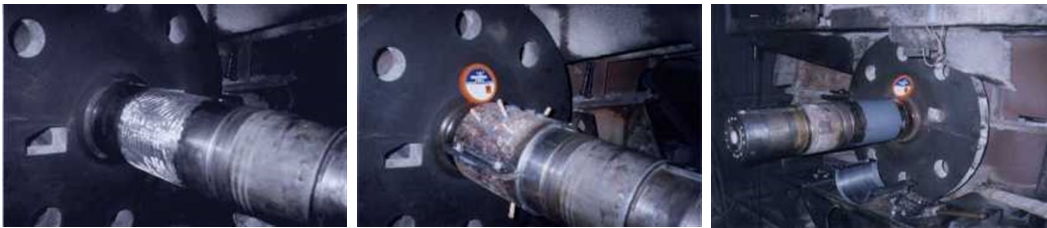
Photograph Descriptions

Shaft damaged by seized bearing.

- * Preparing shaft surface ,
- * Forming with manufactured pipe clamp ,
- * View of repair with former removed ,

Application was carried out in accordance with Belzona Know-How System Leaflet MPT-2.
