SHAFT JOURNAL OF STONE CRUSHER REPAIRED WITH BELZONA

ID: 590

Main shaft of primary stone crusher

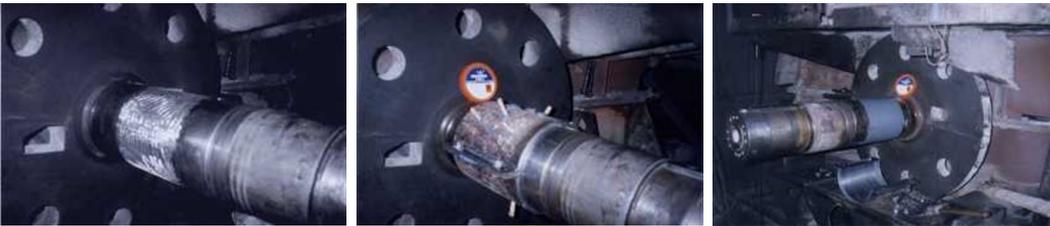
Photograph Descriptions

Shaft damaged by seized bearing.

- * Preparing shaft surface ,
- * Forming with manufactured pipe clamp ,
- * View of repair with former removed ,

Application was carried out in accordance with Belzona Know-How System Leaflet MPT-2.

Belzona allowed vital equipment to be returned to service with minimum disruption to production.
