BELZONA PROTECTS TUNNEL AGAINST EROSION

ID: 5905

Customer Location: Honduras

Application Date: November 2006

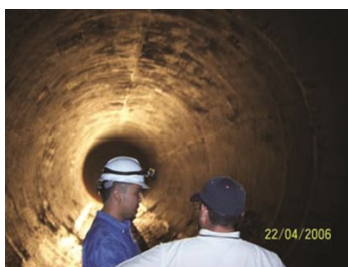
- * General view ,
- * Mortar application ,
- * Restored tunnel ,
- * Belzona 5811 application ,
