BELZONA ENHANCES PUMP EFFICIENCY

ID: 591

Application: CEP-Centrifugal Pumps

Double end suction centrifugal water pump

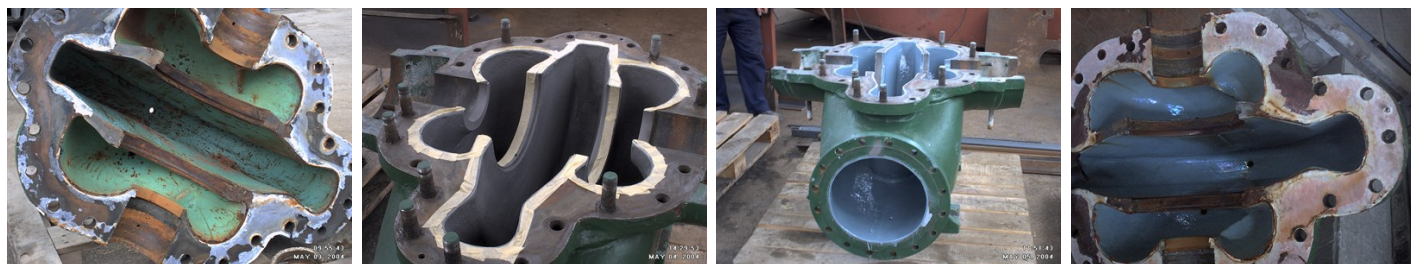
Photograph Descriptions

General erosion/corrosion damage leading to reduced pump efficiency

* Surfaces before application , * Preparation of the casing , * Two coats of Belzona® 1341 applied , * Inspection view after a year in service ,

Application procedures were carried out in accordance with Belzona Know-How System Leaflets CEP-5 and CEP-10.

As a result of applied efficiency enhancement coating and further sealing rings seat repair, reduced power consumption was registered and efficiency increased by 9.91%. The inspection after 12 months in service shows the perfect condition of the applied coating.
