# CONCRETE STEP REPAIR WITH BELZONA

ID: 5912

Application: *FPA-Floor Problem Areas*

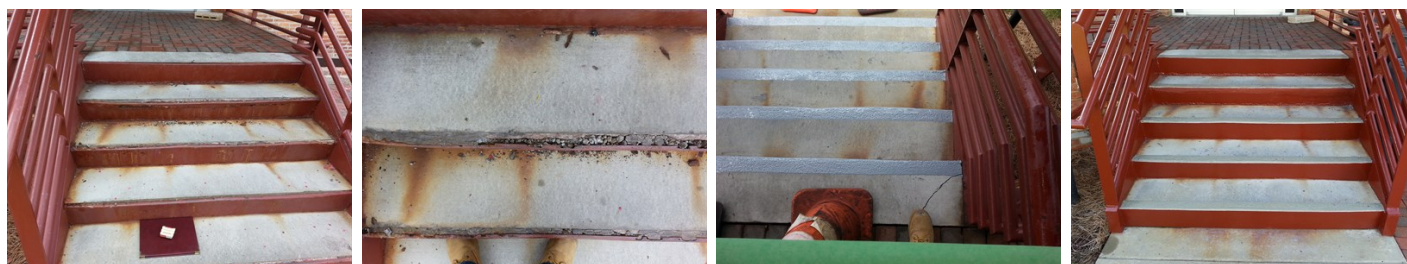
*Concrete steps were broken and deteriorating.*

- \* Prior to application ,
- \* Preparing the surface by removing busted concrete ,
- \* Application of Belzona 4411 with some aggregate ,
- \* Completed application ,

The old concrete was removed so that Belzona 4111 could fill in the spots. After the steps were smoothed over, Belzona 4411 was added with some aggregate.
