CONCRETE STEP REPAIR WITH BELZONA

ID: 5912

Application: *FPA-Floor Problem Areas*

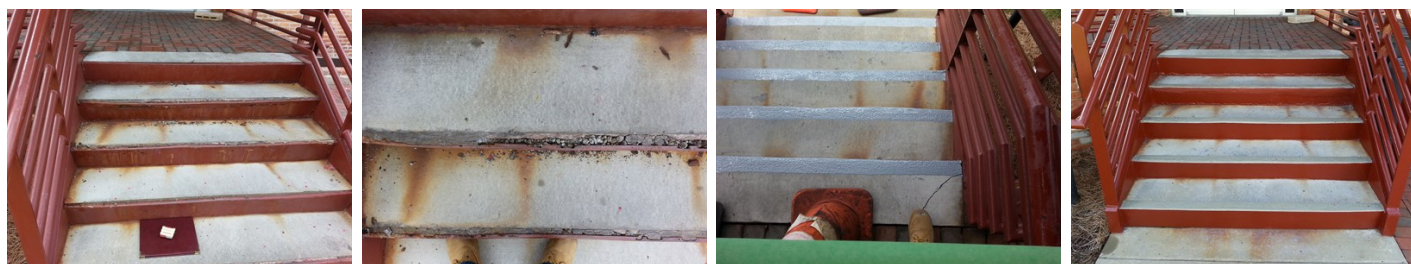
Photograph Descriptions

Concrete steps were broken and deteriorating.

- * Prior to application ,
- * Preparing the surface by removing busted concrete ,
- * Application of Belzona 4411 with some aggregate ,
- * Completed application ,

The old concrete was removed so that Belzona 4111 could fill in the spots. After the steps were smoothed over, Belzona 4411 was added with some aggregate.
