BELZONA REPAIRS FGD WET LIME SLURRY DISTRIBUTION BOXES

Industry: Power

Application: SHM-Solids Handling Machinery

Customer Location: Power Plant, Illinois, USA

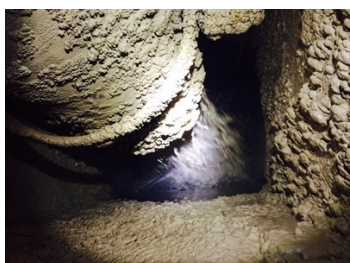
Lime slurry had worn away the existing rubber liner through the steel, and had created holes and washed out areas towards the bottom of the boxes in the cyclone areas.

- * Lime slurry being poured into the box ,
- * Distribution box had been laid on its side for the application to start with welded plate covering one hole visible in the cyclone area ,
- * Belzona 9811 being installed on top of a wet layer of Belzona 2111 ,
- * Belzona 1812 being installed as a grout and void filler ,
