# BELZONA REPAIRS FGD WET LIME SLURRY DISTRIBUTION BOXES

ID: 5914

Customer Location: Power Plant, Illinois, USA

Application: SHM-Solids Handling Machinery

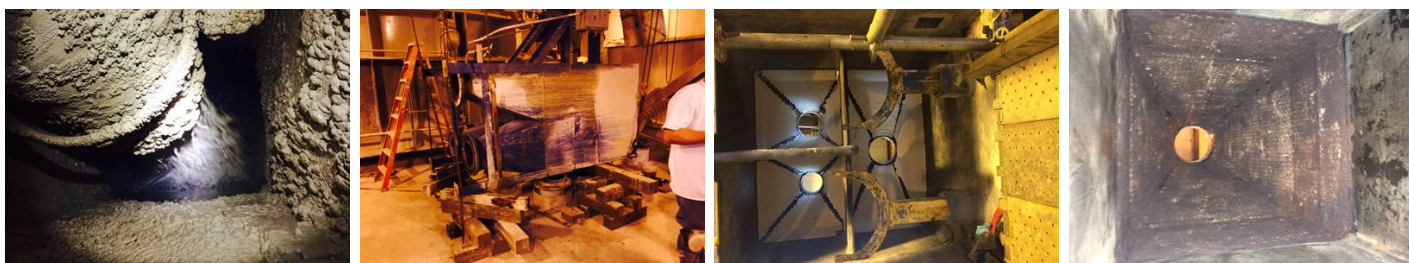
Lime slurry had worn away the existing rubber liner through the steel, and had created holes and washed out areas towards the bottom of the boxes in the cyclone areas.

- \* Lime slurry being poured into the box ,
- \* Distribution box had been laid on its side for the application to start with welded plate covering one hole visible in the cyclone area ,
- \* Belzona 9811 being installed on top of a wet layer of Belzona 2111 ,
- \* Belzona 1812 being installed as a grout and void filler ,

The application was carried out in accordance with Belzona Know-How System Leaflet SHM-7. Surface preparation was done by using a MBX bristle blaster and Belzona roughing brushes. Belzona 1121 was used to seal all holes and rebuild the metal substrate back to its original thickness. Then, Belzona 2911 was used to condition the surface. Belzona 2111 was applied to rebuild worn

rubber areas and it was also used as a bonding agent for Belzona 9811. A layer of Belzona 9811 wear tiles was embedded into Belzona 2111 to help absorb the impact behind the tiles. Belzona 1812 was then used as a grout and to fill/seal any voids.
