BELZONA REPAIRS IRRIGATION HOSE

ID: 5916

Customer Location: Northwestern Washington, USA
Application Date: September 2015

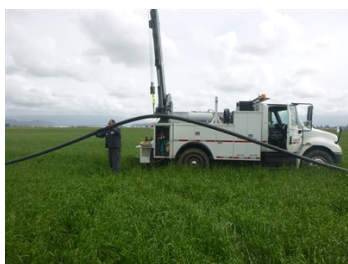
- * Hose lifted to a working height. ,
- * Roughing brush used to obtain a rough surface profile. ,
- * Belzona 2111 with Belzona 9341 applied over the conditioner. ,
- * Completed application. ,

The pipe was lifted to working height for preparation and application. Then, the pipe was scuffed with a roughing brush for 2 inches on both sides of the crack. The pipe was conditioned before applying a layer of gelled Belzona 2111, followed by Belzona 9341 and an overcoat of Belzona 2111.
